## Stains - Identification and Prevention

**Abstract:** This *Technical Note* provides descriptions and photographs that aid in identifying efflorescence and stains on brickwork. It includes information on stain composition, factors that influence their occurrence, and stain prevention.

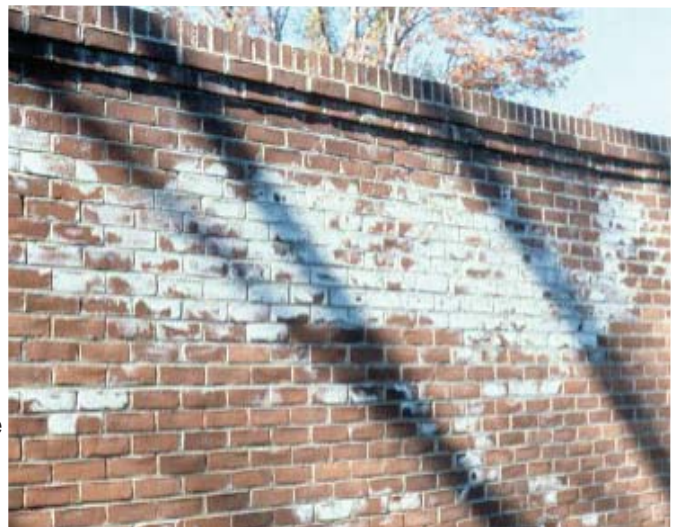
Efflorescence is normally a harmless deposit of water-soluble, white salt crystals, as shown in [Photo 1](#). In some instances efflorescence may appear on mortar joints as shown in [Photo 2](#). Efflorescence may appear in limited areas on the surface of brickwork as shown in [Photo 3](#) or, in extreme cases, cover the entire brickwork surface.

**Photo 1**  
**Efflorescence**

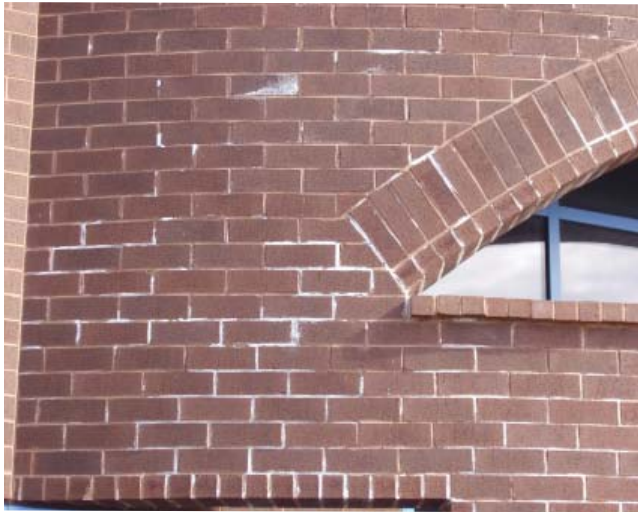
**Photo 2**  
Efflorescence on Mortar Joints

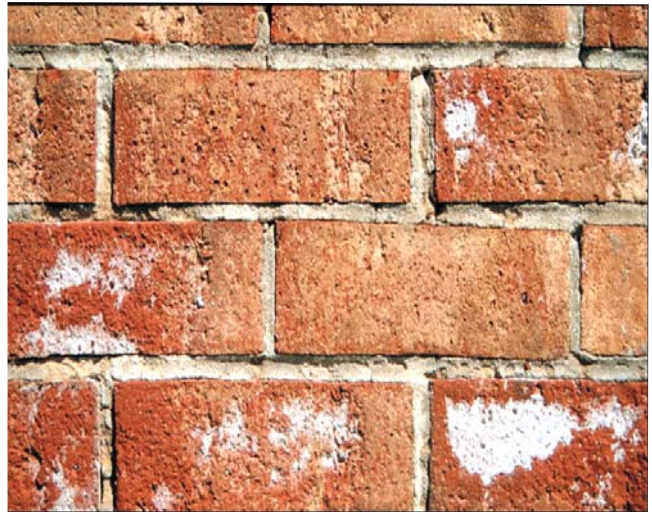
**Photo 3**  
Efflorescence in Limited Areas

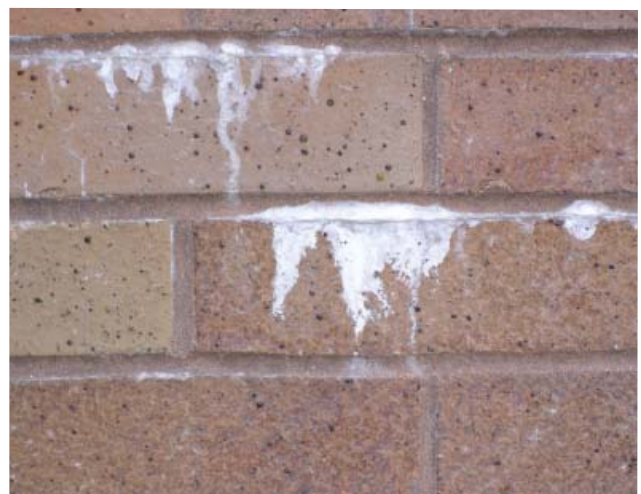
Calcium carbonate deposits, sometimes referred to as “lime run,” usually appear as white or gray, crusty formations originating from a spot and running down the face of the wall, as shown in [Photo 4](#). However, the term “lime run” is misleading since the stain is not a direct result of the lime component in the mortar. In fact, hydrated lime actually helps to reduce the risk of lime run. Lime run nearly always occurs at a small hole or opening or hairline crack in the face of the brick masonry, as shown in [Photo 5](#).

**Photo 5**  
Lime Run

Materials containing cement are sources of calcium compounds and are an integral component of or may be in contact with the brickwork. To reduce the possibility of lime run, excess water must be eliminated or the path must be disrupted. Once lime run begins, it is likely to continue until difficult to the water source is stopped.

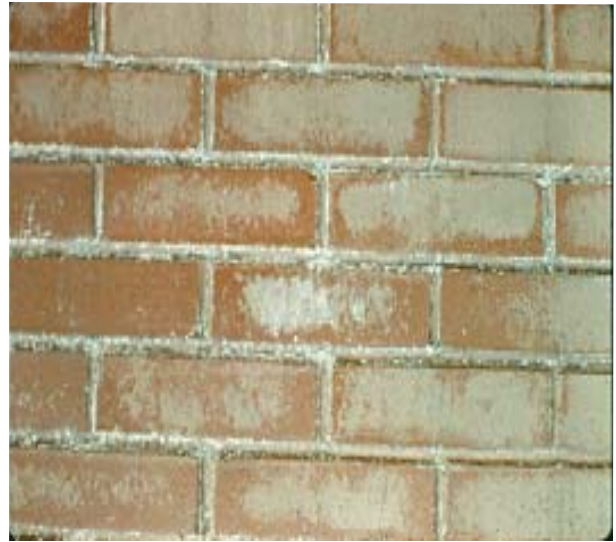
Silicate deposits, sometimes referred to as “white scum,” usually appear as white or gray discolorations on the face of brick masonry, as shown in [Photo 6](#). The discoloration may be present over the entire face of the brickwork or in smaller, irregularly shaped areas. White

A number of mechanisms may precipitate white scum on brickwork. White scum is typically related to the cleaning of brickwork with unbuffered hydrochloric (muriatic) acid solutions or inadequate pre-wetting or rinsing of the brickwork during cleaning.

**Photo 6**  
**White Scum**

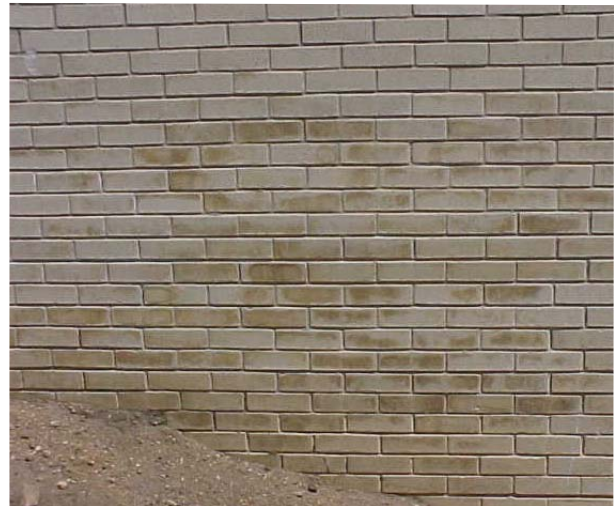
Some brick develop yellow or green salt deposits as shown in [Photos 7](#) (yellow) and [8](#) (green) when they come in contact with water or unbuffered hydrochloric (muriatic) acid. These stains are usually vanadium salts. They may be found on red, buff or white brick; however, they are more conspicuous on lighter-colored brick. The vanadium salts responsible for these stains originate in the raw materials used for the manufacture of the brick. The yellow and green stains are usually vanadyl salts, consisting of sulfates and chlorides, or hydrates of these salts.

Vanadium stains occur in a manner similar to efflorescence, except that vanadium oxide and sulfates are dissolved and result in a solution that may be quite acidic. As water evaporates from this solution at the surface of the brickwork, vanadyl salts are deposited. The chloride salts of vanadium, such as vanadyl chloride, may form as a result of washing with unbuffered hydrochloric (muriatic) acid or excessive moisture exposure. [Ref. 2]

**Photo 7**  
**Yellow Vanadium Stain**

Preventing vanadium stains is important, since they can be difficult to remove and improper cleaning efforts may result in a brown, insoluble deposit. To minimize the potential for vanadium stains, the following steps are recommended:

- Store brick off the ground and under non-staining protective covers.
- Never use or permit the use of highly-concentrated, unbuffered hydrochloric (muriatic) acid solutions to clean light-colored brick.
- Seek and follow the cleaning recommendations of the brick manufacturer.

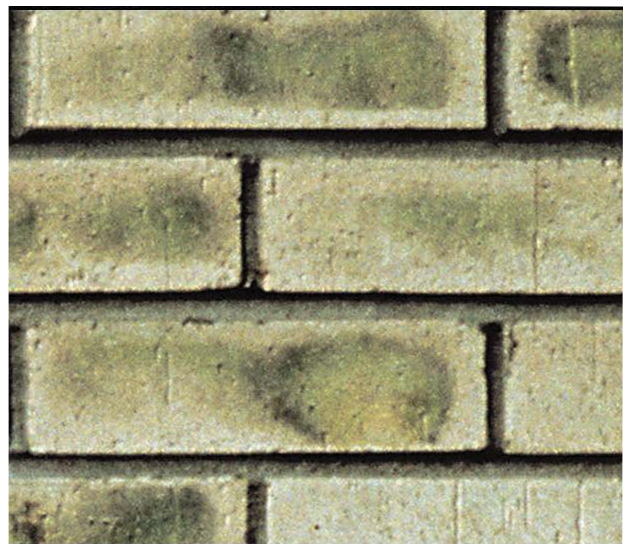
**Photo 8**  
**Green Vanadium Stain**

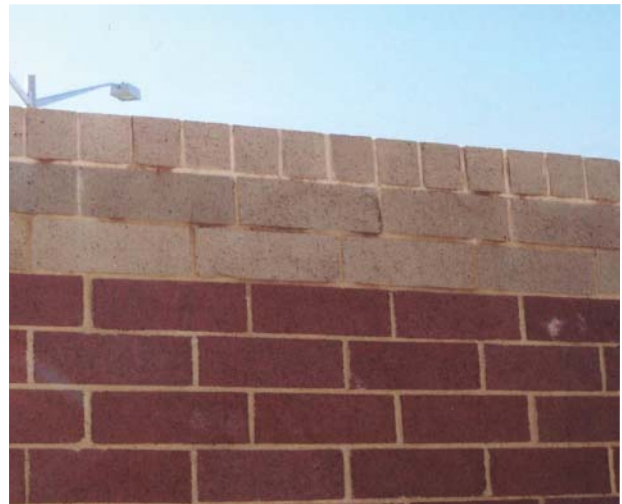
Under certain conditions, tan, brown, or occasionally gray staining may occur on the mortar joints of brickwork as shown in [Photo 9](#). Occasionally, a brown stain will streak down onto the faces of the brick as shown in [Photo 10](#). This type of stain is the result of having a manganese oxide as a coloring agent in tan, brown, black or gray brick and its reaction to an acid.

Manganese staining is closely related to efflorescence, since it is the sulfate and chloride salts of manganese that travel to the surface of the brickwork. When the solution reaches the mortar joints, the salts are neutralized by the cement or lime in the mortar producing insoluble manganese hydroxide. The manganese hydroxide precipitate is deposited on the mortar joint and when dry converts to brown manganese tetroxide resulting in the stain. [Ref. 2]

**Photo 9**  
**Manganese Stain**

Unbuffered hydrochloric (muriatic) acid should not be used to clean tan, brown, black or gray brick. Proprietary cleaning compounds are available for cleaning brick containing manganese. Test for effectiveness and follow the advice of the brick manufacturer.

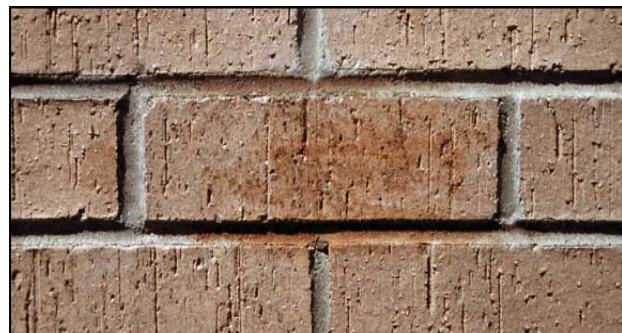
**Photo 10**  
**Manganese Stain**

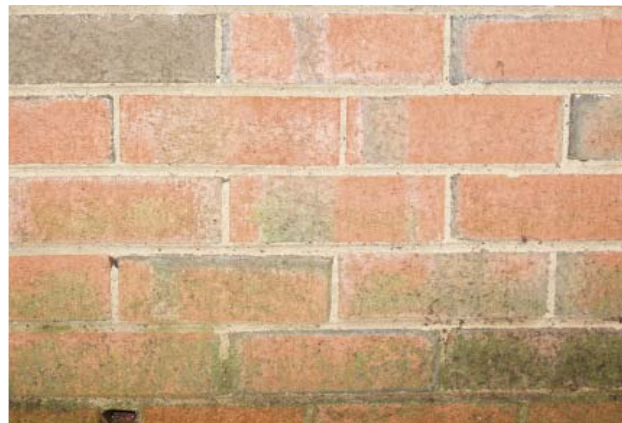
Other stains affecting brickwork are generally caused by external sources such as pollution, organic growth, runoff or others. Usually, the source or composition of these stains is obvious. Organic stains, as shown in [Photo 11](#), can include algae, mold, or other organisms. Certain materials above or adjacent to brickwork such as copper ([Photo 12](#)), bronze, aluminum, synthetic stucco or paint ([Photo 13](#)) can stain brickwork surfaces. In addition, externally caused stains such as hard water from sprinkler systems can effect brickwork ([Photo 14](#)). The color and appearance should be considered during identification. Laboratory or field tests can determine the stain composition and assist in proper identification. Once the correct identification is made, the appropriate method to clean the brickwork can be implemented.

**Photo 11**  
**Organic Stain**

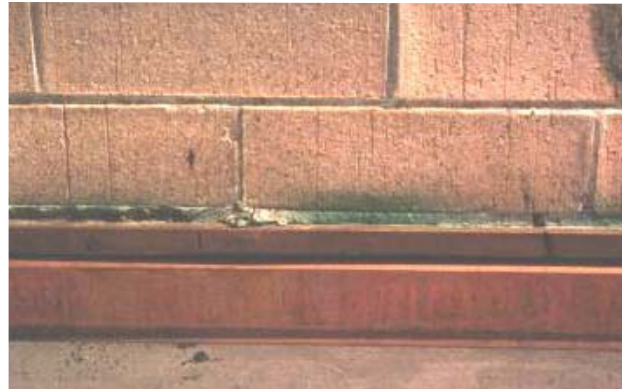
**Photo 12**  
**Stain from Copper**

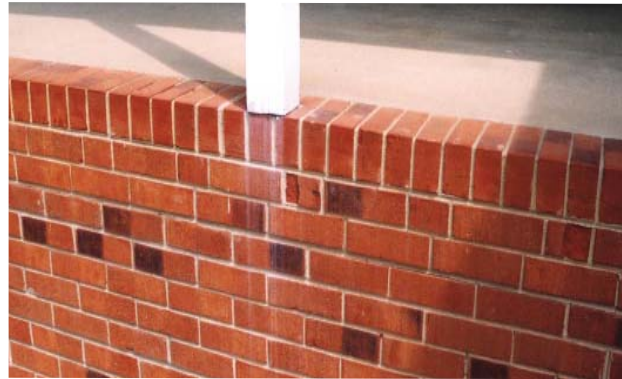
**Photo 13**  
**Runoff Stain from Paint**

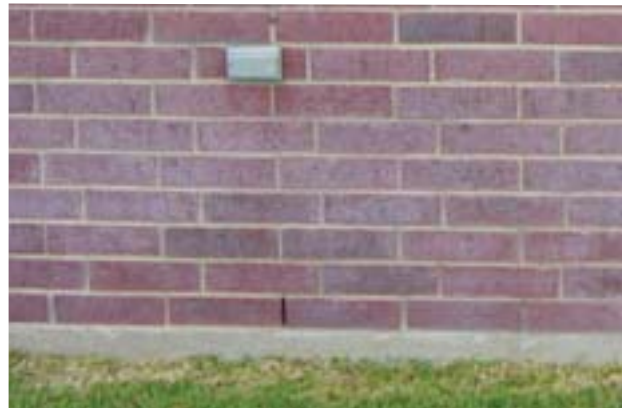
**Photo 14**  
**Hard Water Stain**

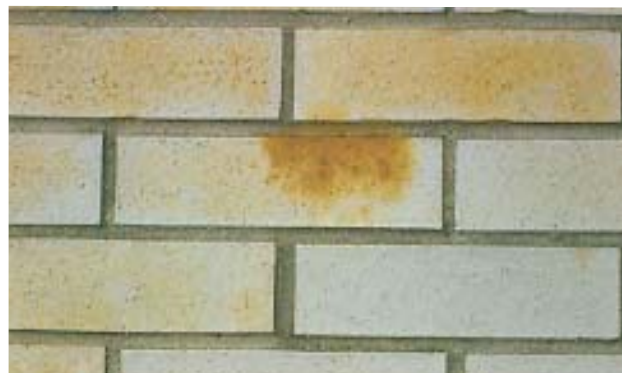
Rust-colored stains may actually be corrosion, as shown in [Photo 15](#). Such stains can be the result of

corrosion of wall ties or joint reinforcement in or adjacent to the brickwork. The use of improper mortar additives or ingredients, placement of wall ties or joint reinforcement with inadequate cover, welding splatter on the brick, or the corrosion of a material placed on the brick cube or pile prior to being laid in the brickwork can all attribute to these stains.

**Photo 15**  
**Rust Stain**
