# Moisture Performance Comparison of Typical Residential Wall Assemblies

*Prepared for*  
The Brick Industry Association

*Prepared by*  
NAHB Research Center, Inc.  
400 Prince Georges Boulevard  
Upper Marlboro, MD 20774-8731  
[www.nahbrc.com](http://www.nahbrc.com)

Report #20100324\_3287

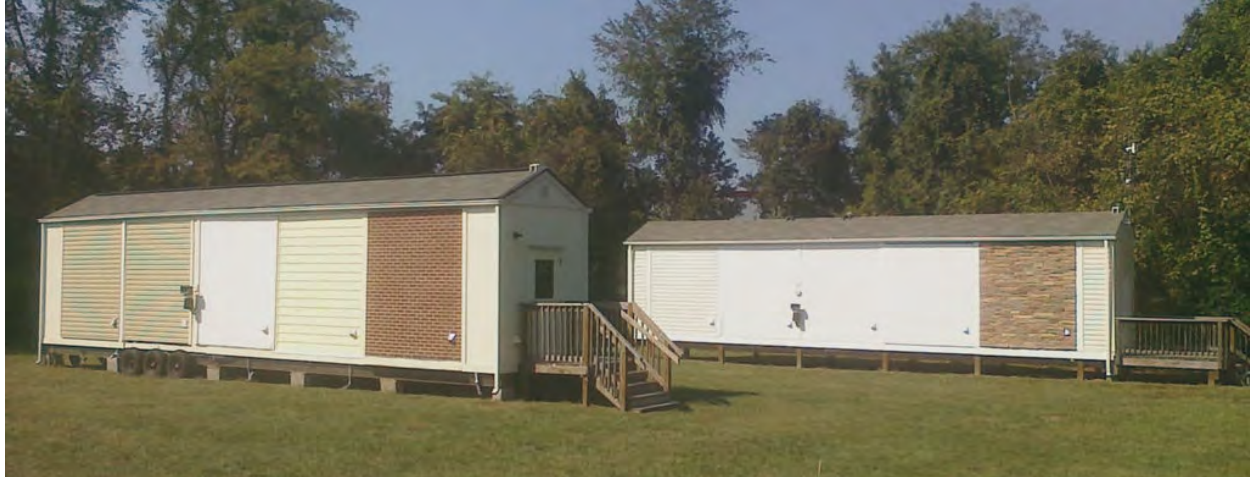
Figure 1: South-facing walls of test structures (building 1 right, building 2 left)

Roof overhang was limited to the four-inch gutter and, therefore, test panel exteriors had appreciable exposure to the elements. Gable end walls were clad with horizontal lap vinyl siding over a WRB and OSB. All products were installed in accordance with manufacturer recommendations or, if recommendations were unavailable, in accordance with the prevailing building code.

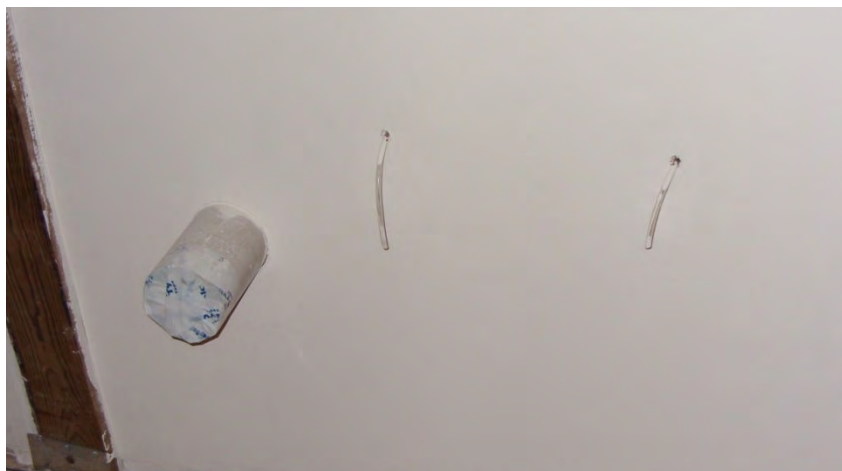
**Figure 2: Interior face of one wall showing dosing tubes, and dryer vent penetration**

The center stud bay was designed to simulate a window opening. Because leakage of installed windows varies, windows were not installed. Instead, two 1/4-inch dosing tubes were installed to allow controlled injection of water to simulate leaks. As reported previously, water leakage events were simulated on four occasions during the later months of the monitoring period. The first three leakage events were independent one-day injections that resulted in no increase in moisture content of the sheathing. The fourth leakage event was performed over five consecutive days.

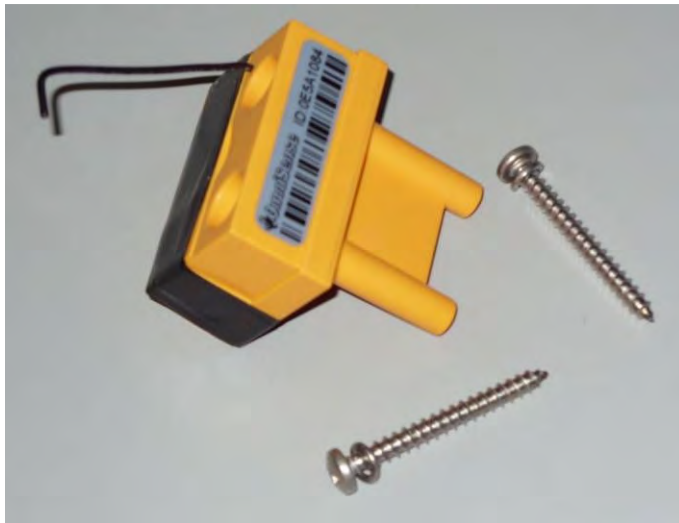
**Figure 2. Wireless temperature, humidity, and wood moisture sensor**

Forty-four sensors capable of recording temperature, relative humidity, and wood moisture content were installed in each wall section. Each sensor (pictured in Figure 3) includes two, 2-inch stainless steel screws that secure each device to wood framing or OSB sheathing and penetrate  $\frac{3}{8}$ -inch into the substrate to obtain a conductance reading correlated to substrate moisture content. The sensors are capable of measuring moisture content between 7 and 40 percent, temperature between negative 40°F and 185°F, and relative humidity from 0 to 100 percent at programmable time intervals. Data was transmitted wirelessly from the sensors every 30 minutes during the testing period to researchers via the internet. Sensor placement is depicted in Figure 4.

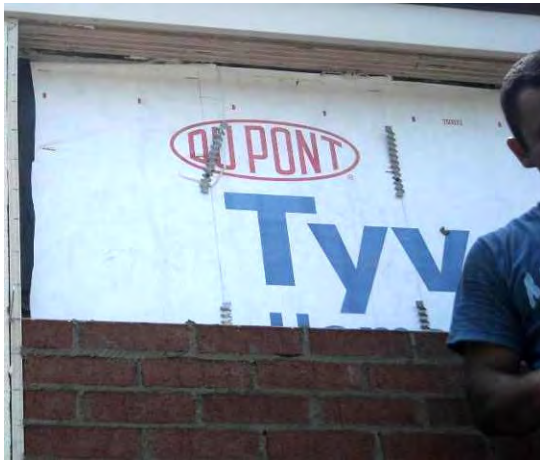
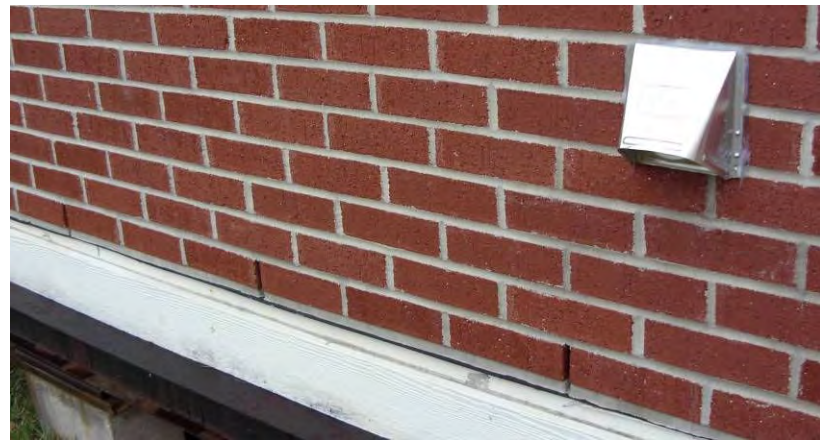
Weep Holes

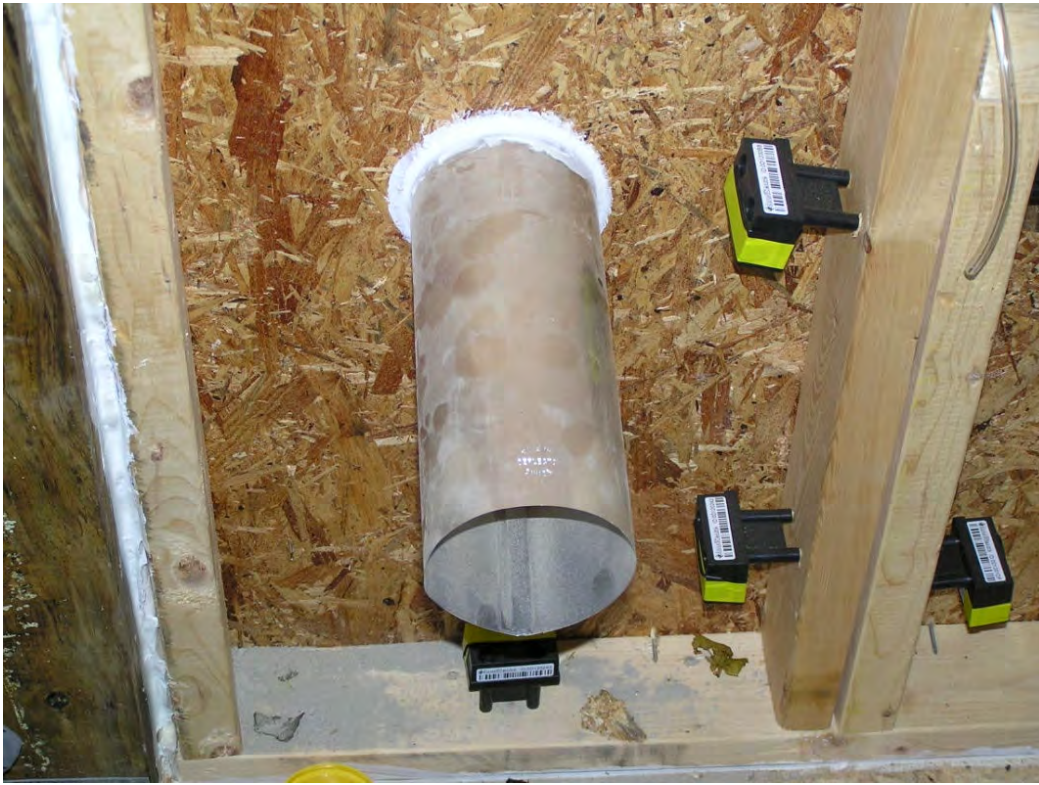
Wireless moisture sensors installed in an OSB stud bay with the dryer vent

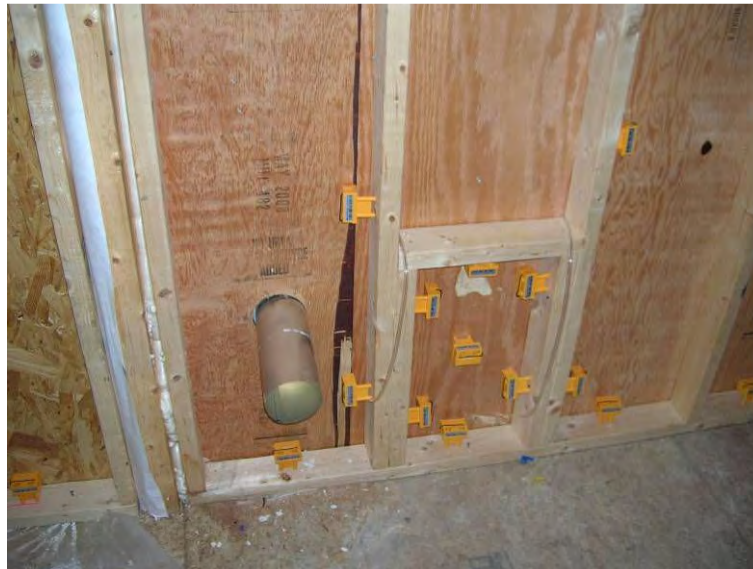
Wireless moisture sensors installed in the plywood stud bay with the dryer vent

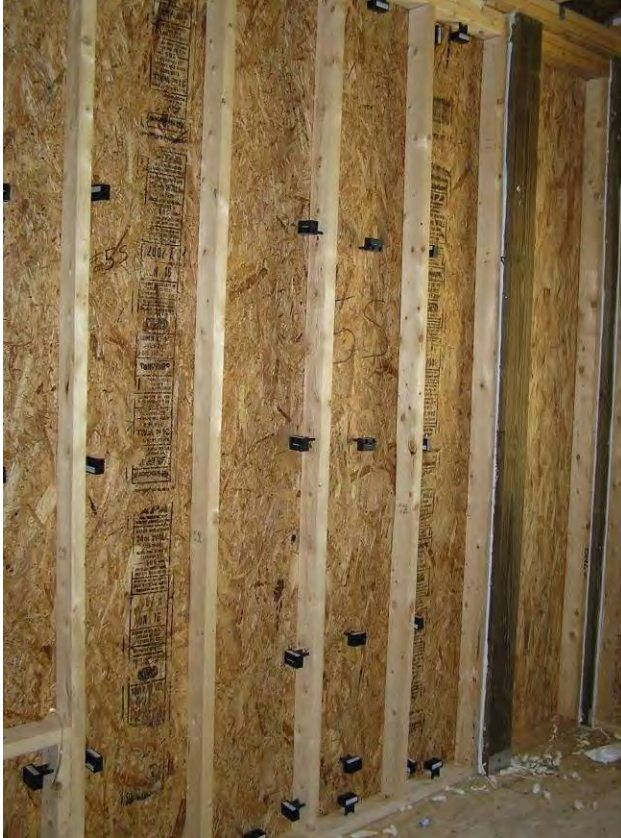
Wall Cavity before insulation was installed

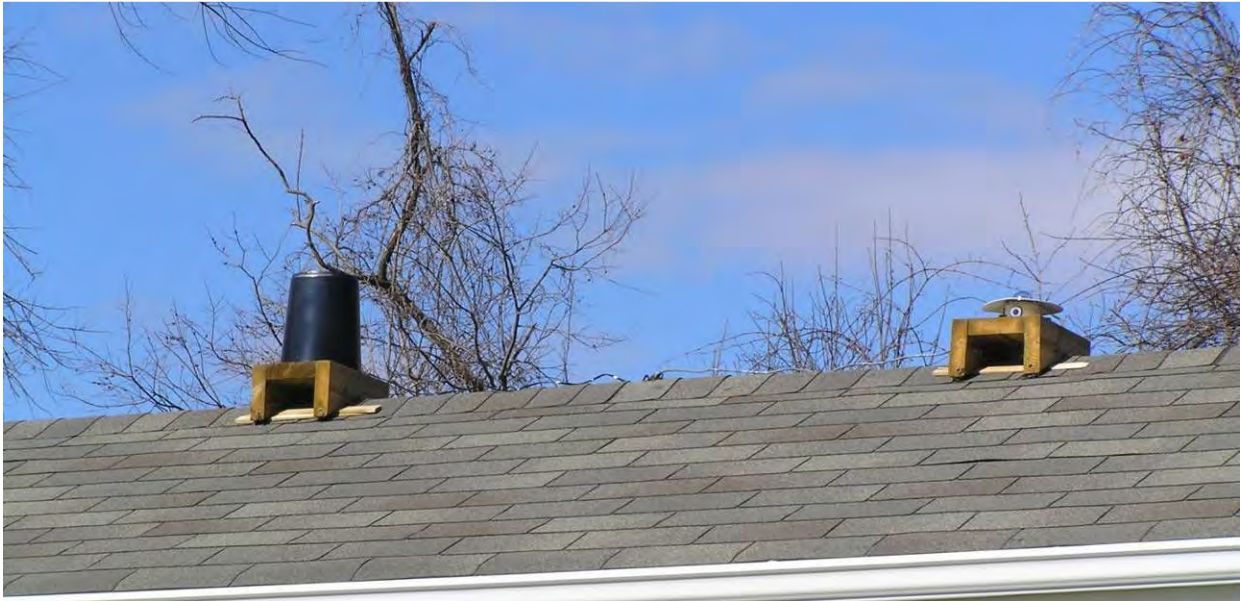
Rain gauge and horizontal solar radiation sensor

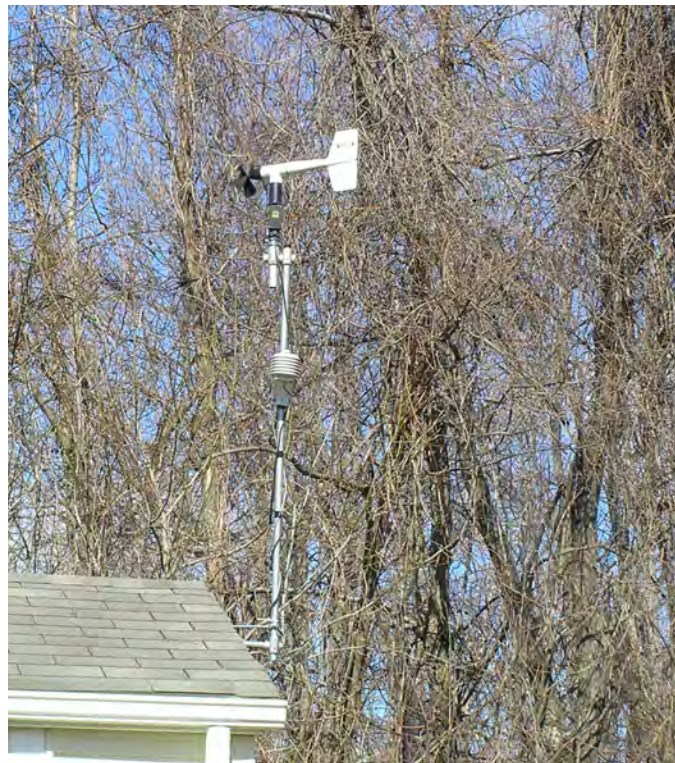
Anemometer, temperature humidity sensor

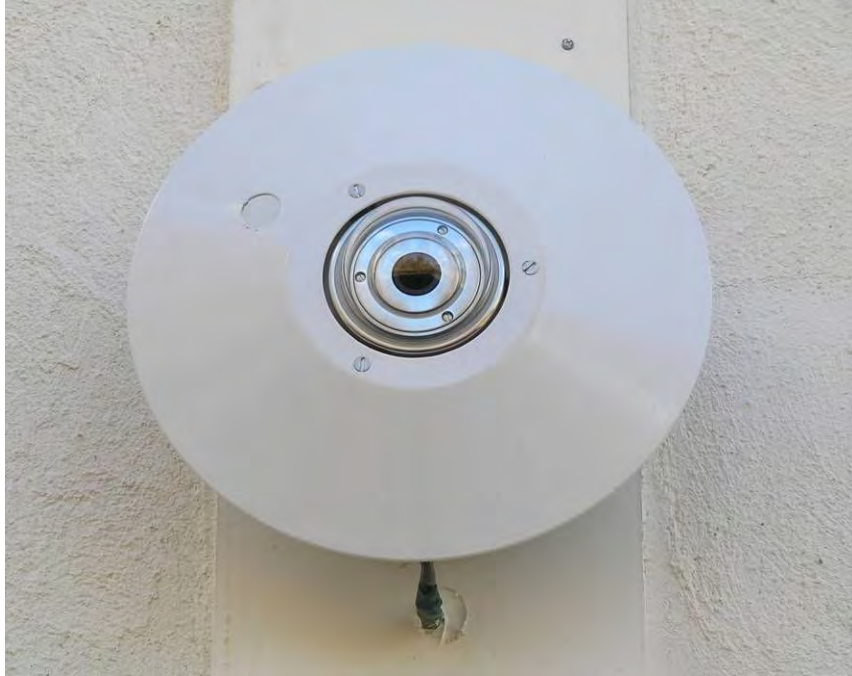
Vertical pyrometer located on wall surface

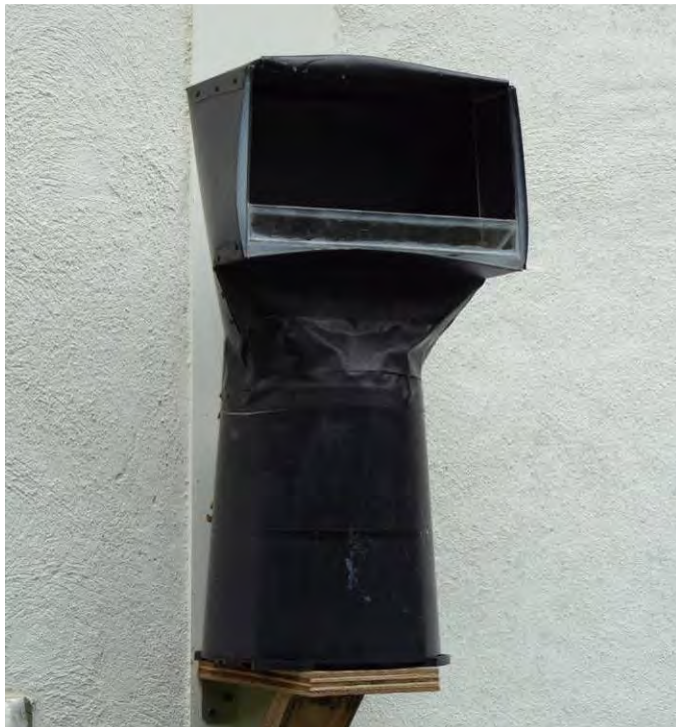
Wind driven rain sensor

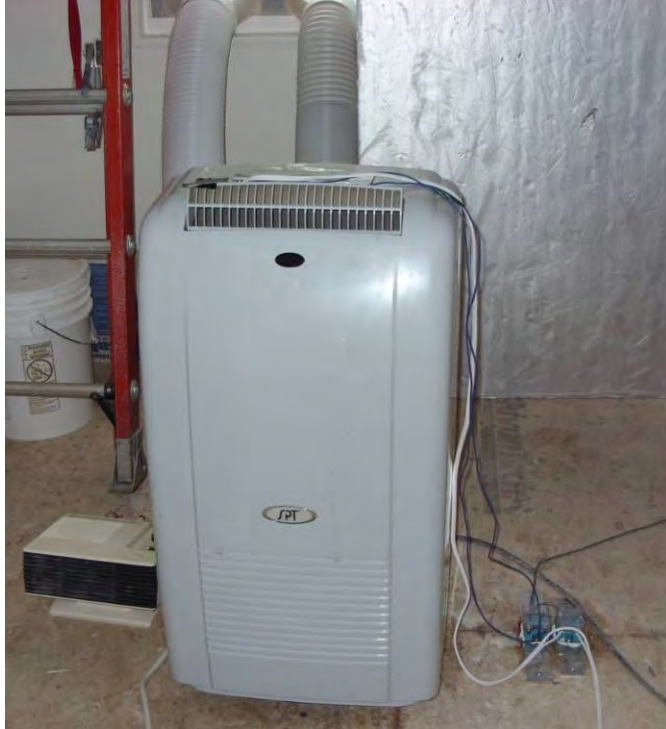
First stage air conditioner with direct vent
